2020 NFPA 58 UPDATE:

FACE SEAL INSPECTION GUIDE

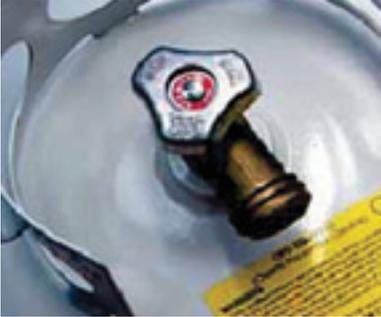
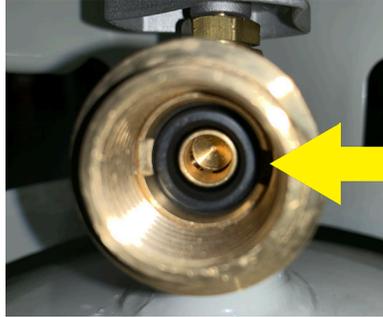
This is a 20 lb cylinder equipped with an OPD valve and a face seal that is in good condition.

YES? THEN YOU NEED TO INSPECT THE FACE SEAL.

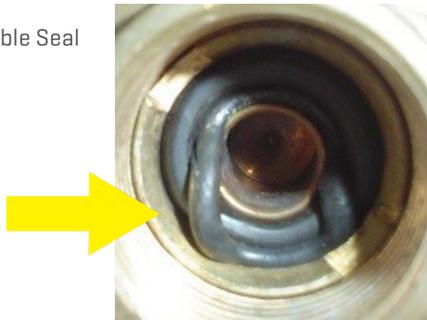
Filling Double Seal

These are some examples of damage. If the face seal doesn't look like the one above, or if you are concerned:

DO NOT FILL THE CYLINDER.

Advise the cylinder owner that the cylinder must be removed from service.
